**Paper Number: 2015-04**

## **Implementing Pipelines Integrity Management Using KPIs**

**Sherry Rao**

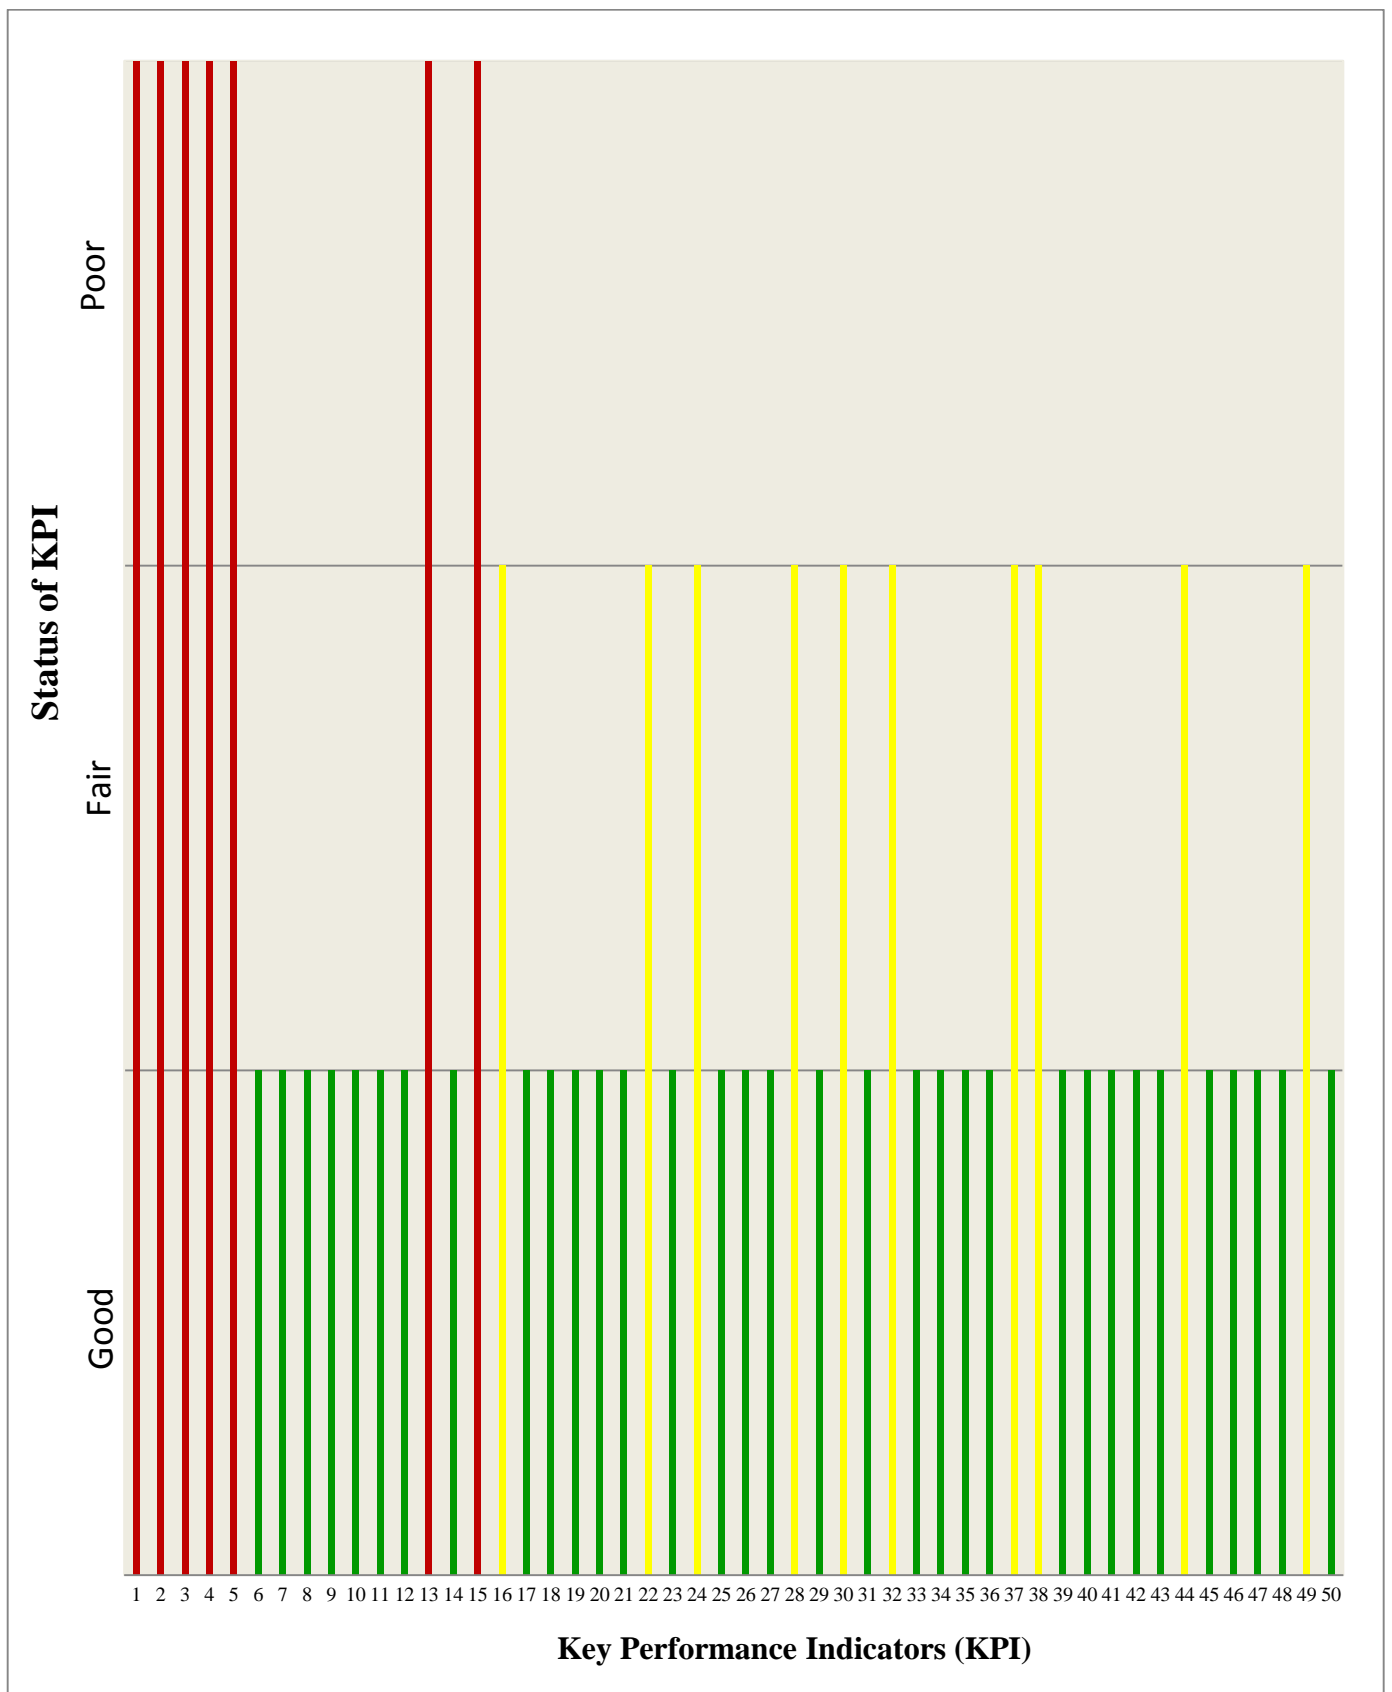
Figure 1. Status of Key Performance Indicators (KPIs) with Respect to Corrosion Control in the Oil Production Pipeline Discussed in this Paper

The status of implementation of the 50 KPIs may also be graphically presented (as shown in Figure 1). In Fig. 1:

- Green bar indicates that the KPI was implemented appropriately (good); 33 KPIs with respect to corrosion control were implemented appropriately;
- Yellow bar indicates that the KPI was implemented inadequately (Fair); 10 KPIs with respect to corrosion control were implemented inadequately;
- Red bar indicates that the KPI was implemented poorly (poor); 7 KPIs with respect to corrosion control were implemented poorly.
