**Paper Number: 2021-03**

# Investigation of Internal Corrosion Mechanisms of a Pipeline with Specified Parameters: Application of Various Mitigation Strategies

Mohammadali Shahsavari

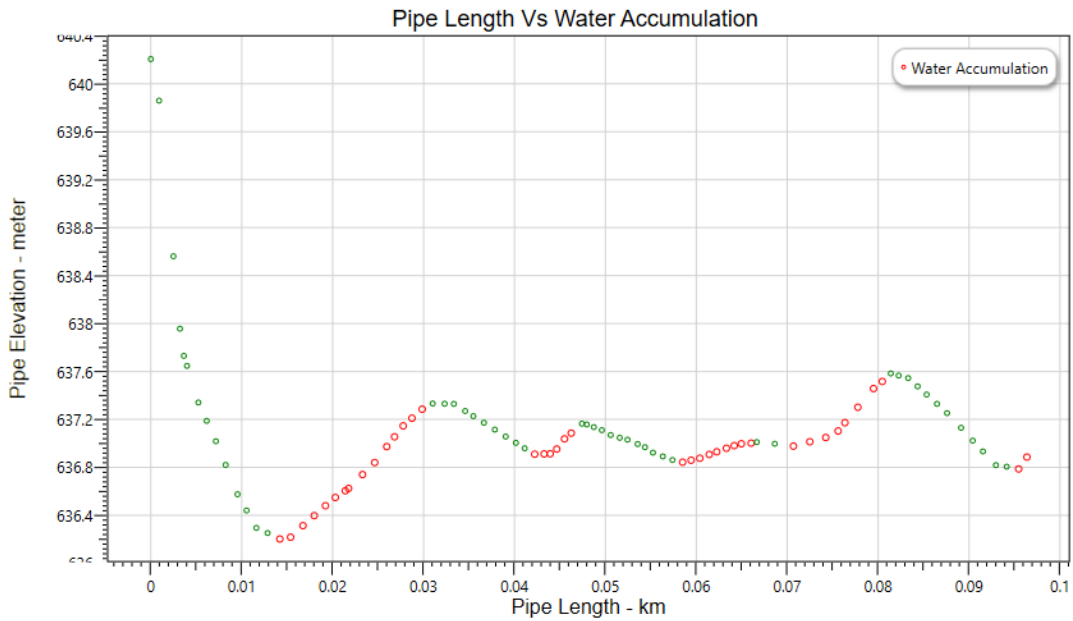
Fig. 1 shows the pipe length vs. water accumulation. It is known that the water accumulation areas are potential locations for corrosion [4]. According to Fig. 1, water accumulation occurs on the following distances along the pipeline length:

- 1- ~ 14-30 m
- 2- ~ 42-48 m
- 3- ~ 58-67 m
- 4- ~ 71-81 m
- 5- ~ 95-98 m

Figure 1: Pipe length (km) vs. pipe elevation (m)

It is expected to see the corrosion at water accumulated areas. Fig. 2 shows that the only corrosion damage mechanism (CDM) in this pipeline, based on the operational parameters, is Microbiologically Influenced Corrosion (MIC). As expected, this type of corrosion (MIC) occurred on the water accumulation areas.

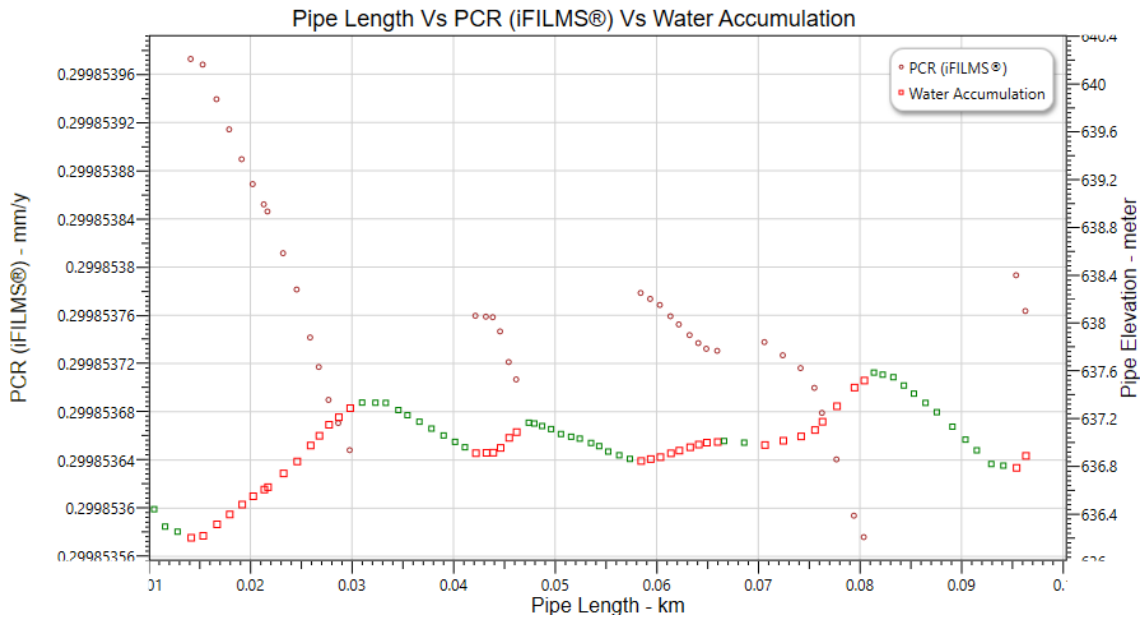
As a result of water accumulation and presence of other required factors, MIC would occur and in turn, it can result in localized corrosion, which can lead to pit formation or pitting corrosion (PC). The stagnant flow inside the pipeline can exacerbate this situation. Also, pitting corrosion is one of the corrosion damage mechanisms which is normally seen in the pipelines, where water accumulates [4]. Using iFILMS<sup>®</sup> software, Pitting Corrosion Rate (PCR) of the pipeline was evaluated and are shown in Fig 3. As expected, the PC was seen at water accumulated areas. The maximum PCR was estimated to be around 0.3 mm/y. In the industry, normally the corrosion rates less than 0.1 mm/y are considered as non-corrosive conditions. Therefore, anything above the 0.1 mm/y represents the corrosive condition [4,10].

Figure 3: Pipe length (km) vs. PCR (mm/y) and pipe elevation (m)

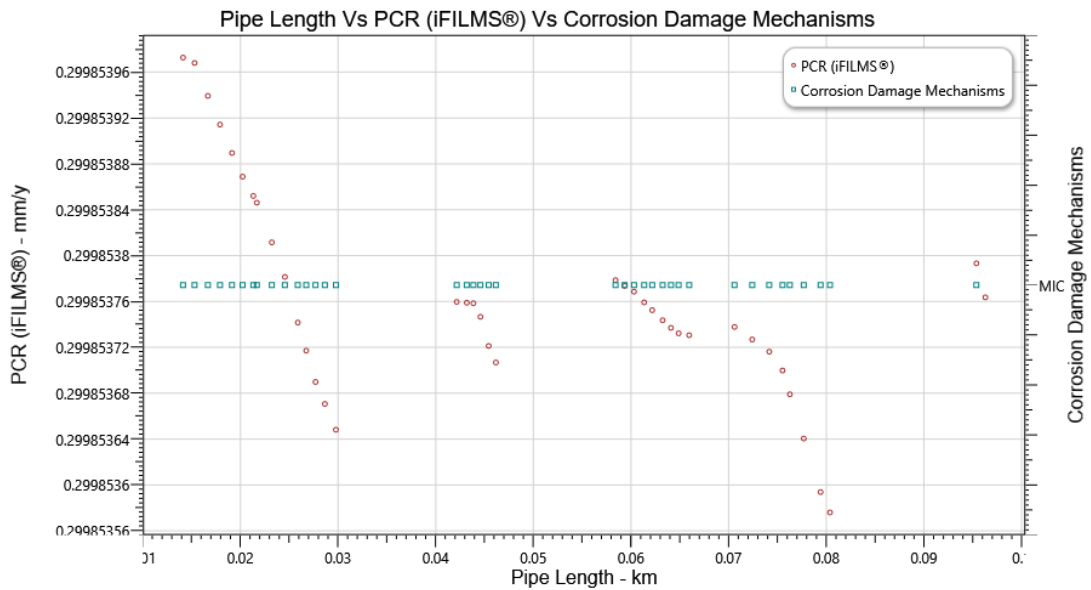
Fig. 4 shows the PCR values and CDM (which is MIC), along the length of the pipeline. According to the extracted data from iFILMS<sup>®</sup>, MIC occurs in 40 locations, of which 15 are high priority corrosion locations. More details about these locations are provided in Appendices (section 5.2). The unmitigated remaining wall percentage (RWP) is 84.86%, whereas the time to fail (TF) for the pipeline is 13 years.

Figure 4: Pipe length (km) vs. PCR (mm/y) and CDM

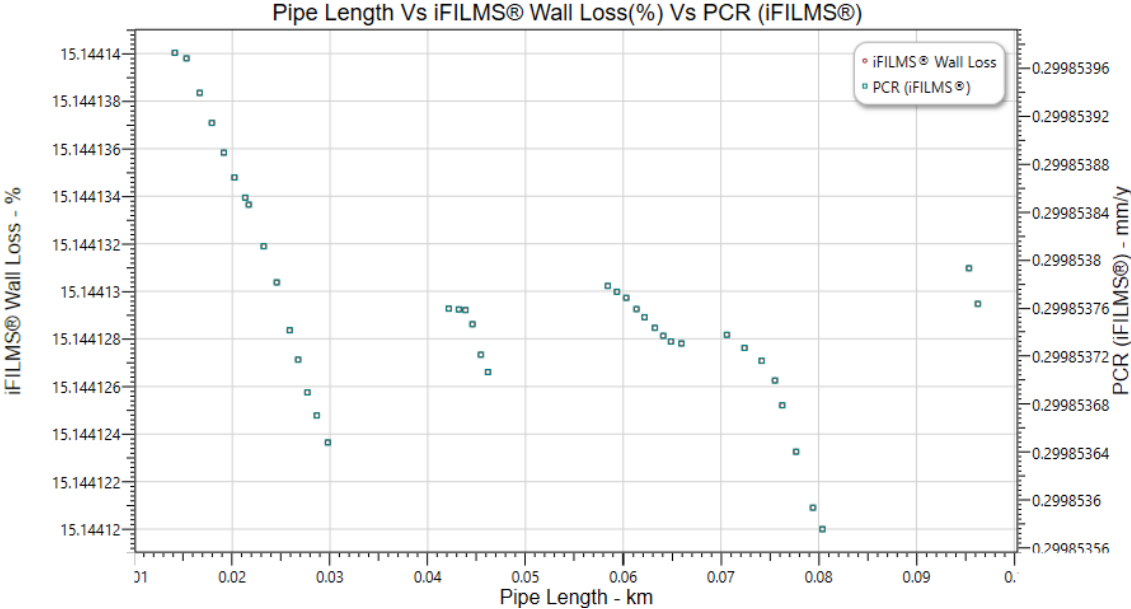
Fig. 5. shows the pipe length vs. wall loss percentage and PCR. It can be seen from Fig. 5 that the pitting corrosion degrades the pipeline wall about 15% by time. The PCR higher than 0.1 mm/y, and 15% wall loss are valid reasons to consider an appropriate mitigation strategy to control the corrosion that resulted in this amount of wall loss and corrosion. Fig. 5 also shows that the wall loss occurred at the distances where the MIC happened (overlapped green and red points).

Figure 5: Pipe length (km) vs. wall loss (%) and PCR (mm/y)

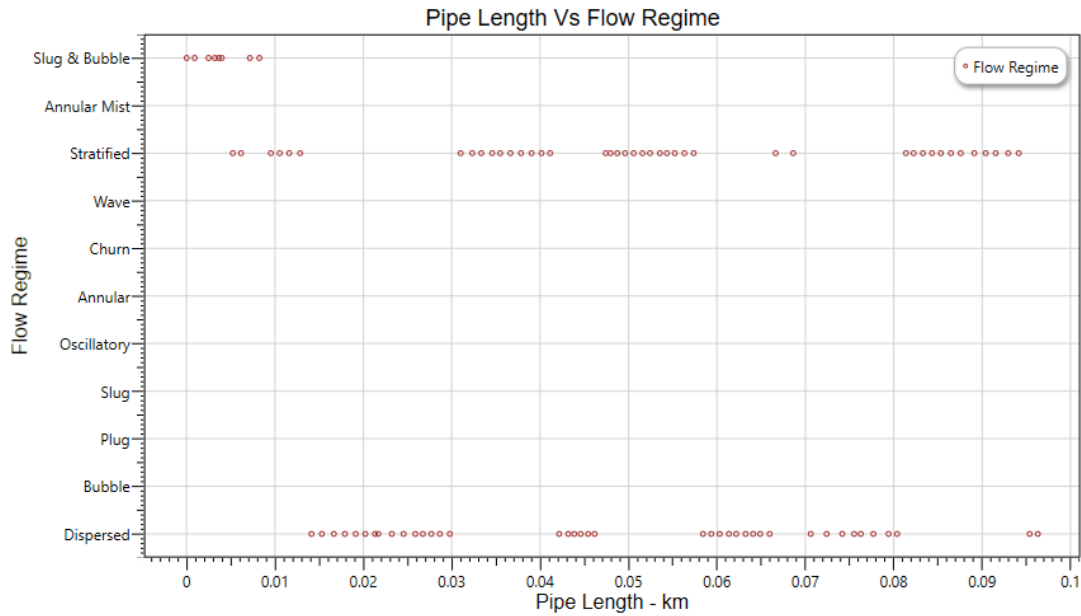
Fig. 6 shows the flow regime along the length of the pipeline. According to the iFILMS® results, flow types of Slug & Bubble, Stratified, and Dispersed are seen along the various locations of the pipeline. The type of flow regime can be affected by operational parameters.

Figure 6: Pipe length (km) vs. Flow regime

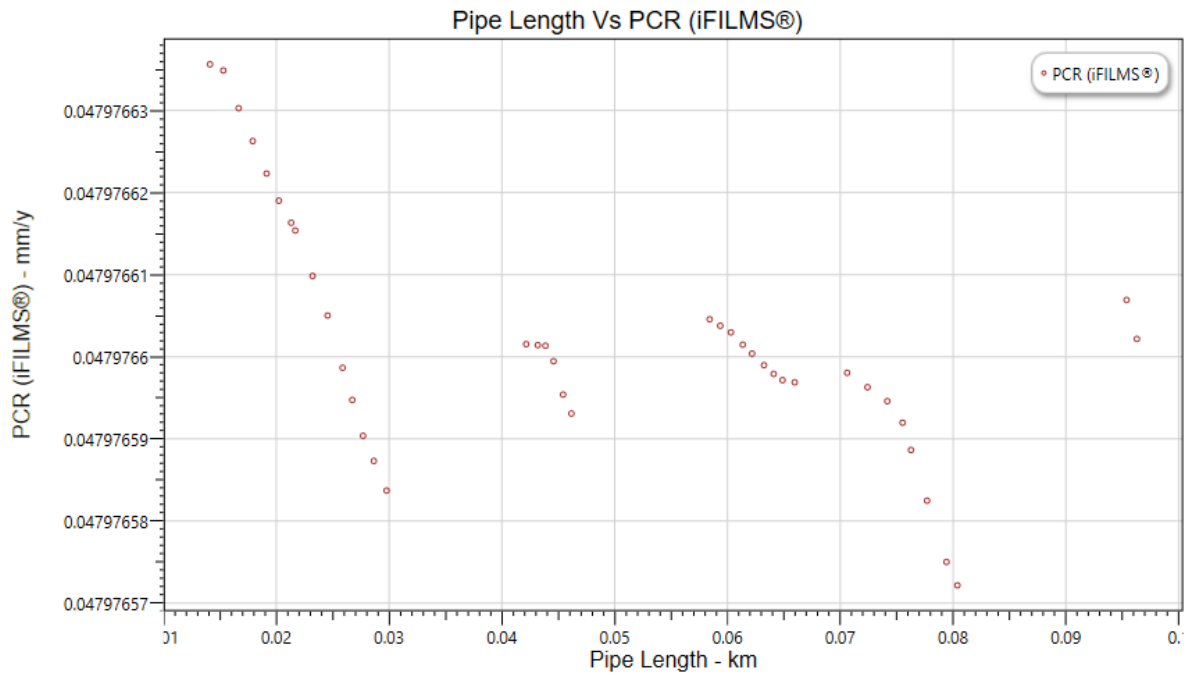
Figure 10: Pipe length (km) vs. PCR (mm/y): **Mixed yearly pigging and batch inhibitor**

To study further the effect of combined mitigation strategies on the corrosion rate of the pipeline, pigging and batch inhibitor strategies were selected. The iFILMS<sup>®</sup> results showed that the yearly pigging and batch inhibitor can decrease the PCR to around 0.05 mm/y (Fig. 10), which is the least value that was obtained so far, compared to the sole use of either batch inhibitor or pigging. Moreover, yearly pigging and monthly batch inhibitor can decrease the PCR to around 0.03 mm/y (Fig. 11). Considering all the scenarios, with one and two mitigation strategies, the last scenario

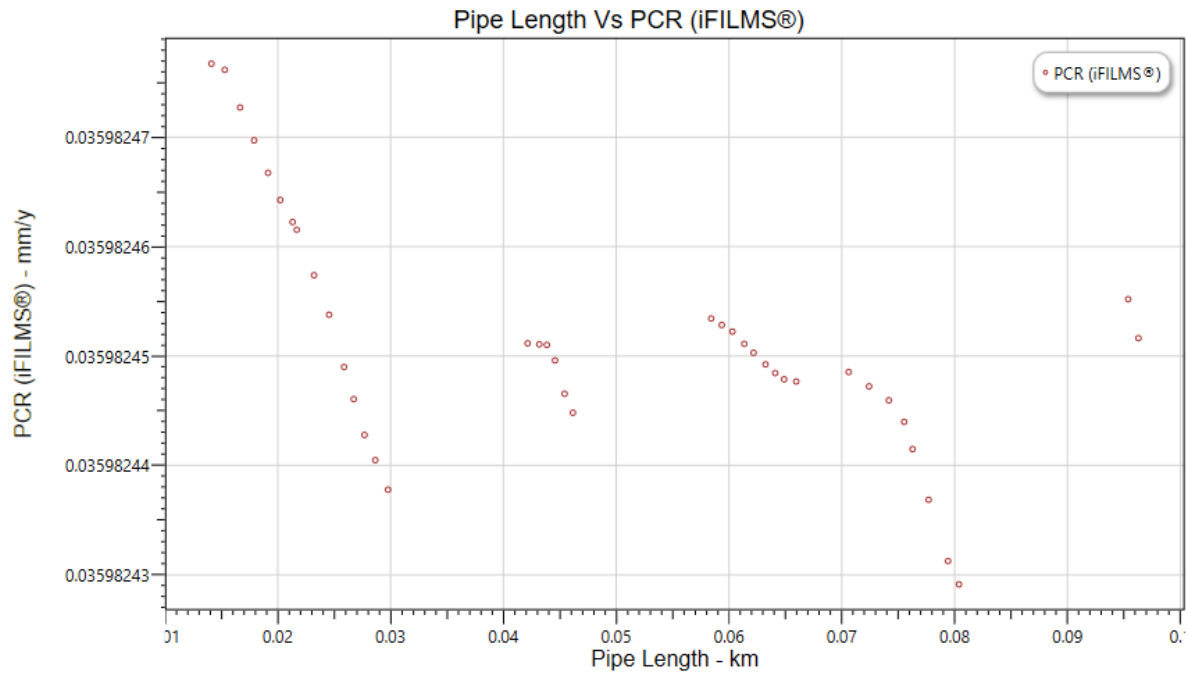
Figure 11: Pipe length (km) vs. PCR (mm/y): **Mixed yearly pigging and monthly batch inhibitor**

of yearly pigging and monthly batch inhibitor seems to be effective to decrease the corrosion rate to less than 0.1 mm/y, even with the safety factor of 0.5 [2].

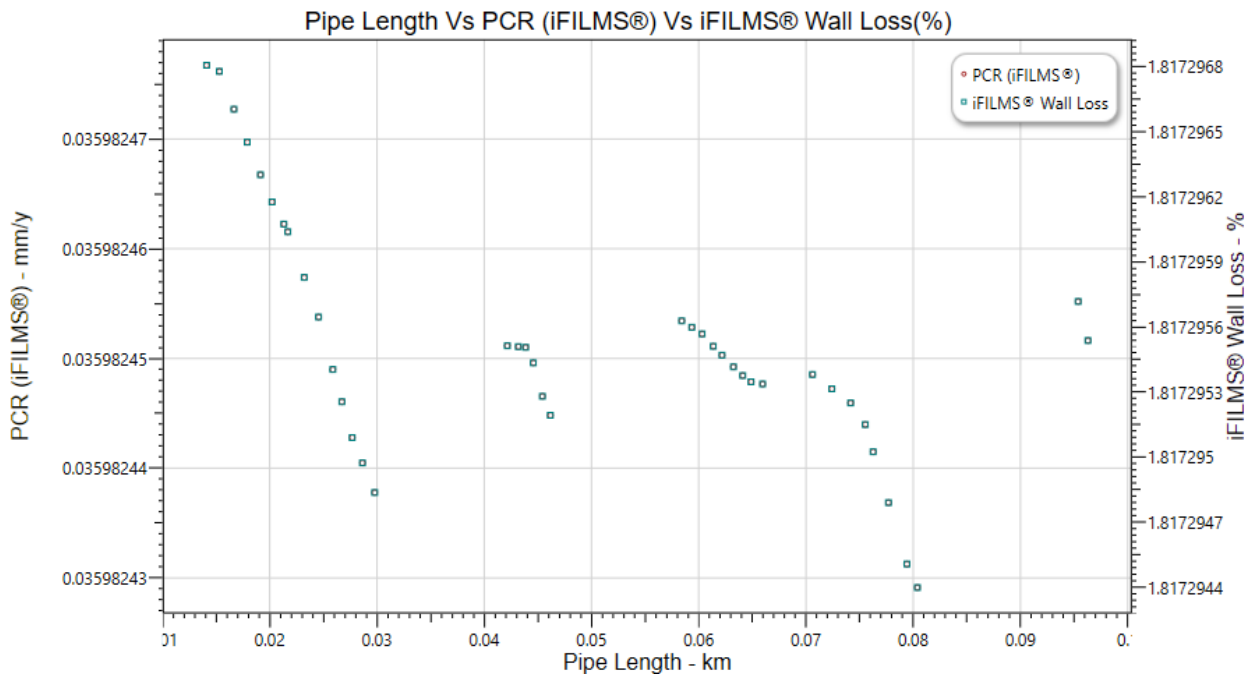
Figure 12: Pipe length (km) vs. PCR (mm/y) and wall loss (%): **Mixed yearly pigging and monthly batch inhibitor**

It should be noted that the pigging and batch inhibitor with lower frequency of application was not studied due to the monetary considerations. Table 4 summarises the details on PCR (mm/y), RWP, and TF for each of the evaluated scenarios. Fig. 12 also shows that using the proper mixed mitigation strategy, the wall loss percentage can be decreased from 15% (RWP=85%) to around 1.81% (RWP=98.18%).

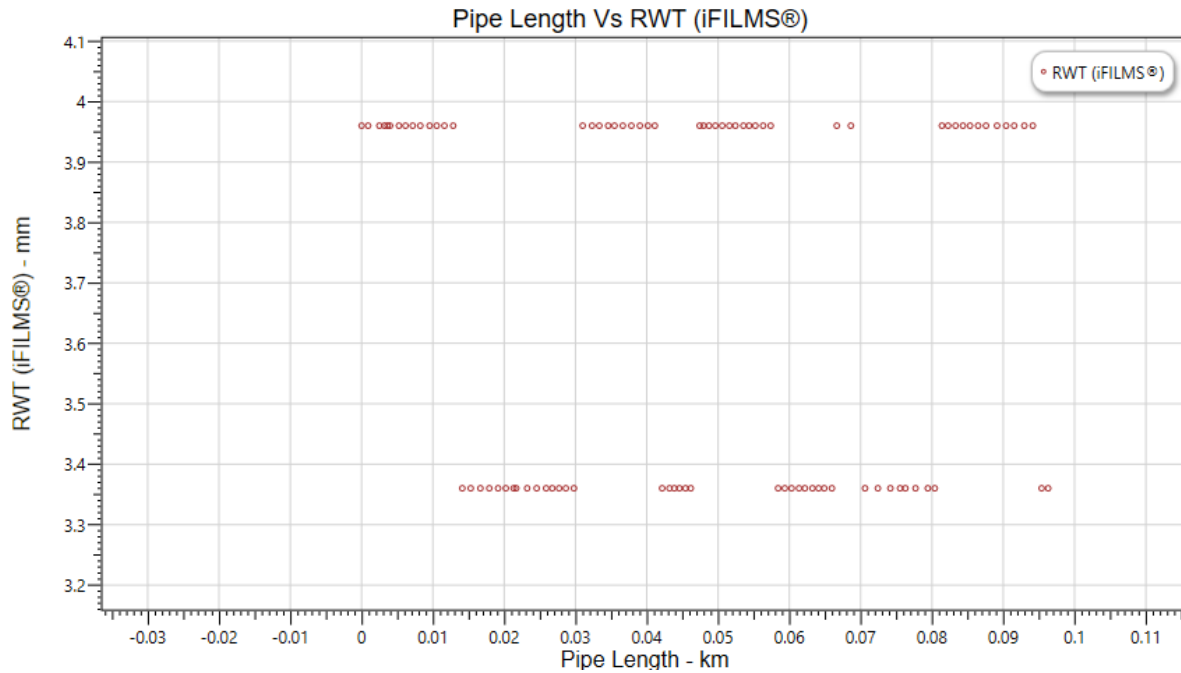
Figure 13: Pipe length (km) vs. RWT (mm): **Unmitigated pipeline**
